Atlantic Richfield Company

April 18, 2017

RE: Leviathan Mine Site: Update on Limited Access Season Site Conditions
April 5 - 12, 2017

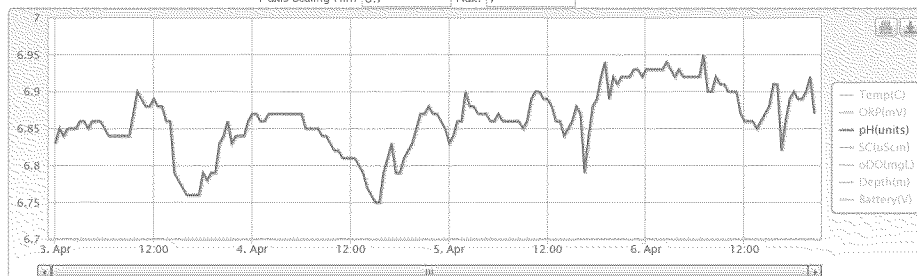
It appeared from the photos that the separation may have resulted from ice pushing against the riser pipe assembly. Atlantic Richfield does not normally have personnel at the site at this time of year, and the pipe separation was not the result of any human-caused activity. It also appeared that there were only a few inches of standing water in Pond 4 above the pipe separation, and the section of pipe below the separation was intact. According to Doug Carey, LRWQCB Board crews who were at the site earlier in the week did not observe any discharge from the Pond 4 overflow pipe, so we assume the separation occurred sometime between April 4 and April 6, 2017. pH measurements from EPA's data sonde in Leviathan Creek at 4L did not suggest that the resulting discharge from Pond 4 was having any significant effect on surface water quality during this time:

At 5:49 PM PDT on April 6, 2017, Atlantic Richfield notified EPA of these conditions by email. Atlantic Richfield also described its plan for repairing the pipe separation by sending field personnel to the site the following day, weather permitting.
